# **New airplanes for old airfields**

**An airport airside  
construction and  
rehabilitation  
illustrated story**

## Houari Boumedienne International Airport - Algiers

## Faro Airport - Portugal

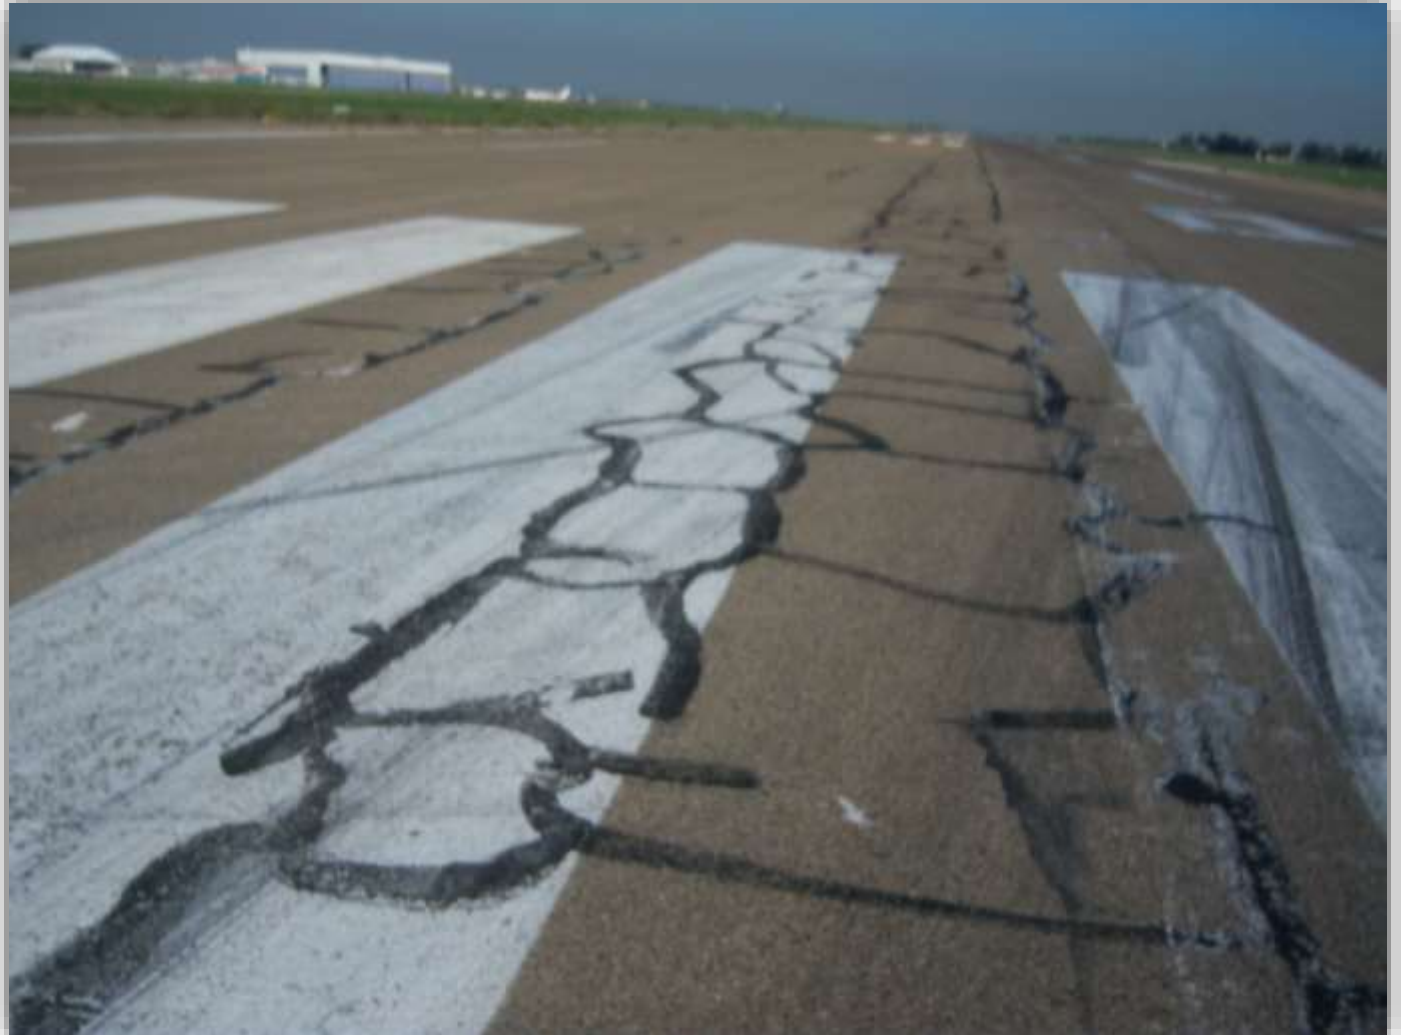
### MAIN RUNWAY 05-23 REHABILITATION

- 0-2500m built in 1960 prestressed concrete slab
- 2500-3500m extension plain concrete slabs 37cm thick
- Reinforcement in the 80's bituminous mix base and bituminous concrete wearing surface

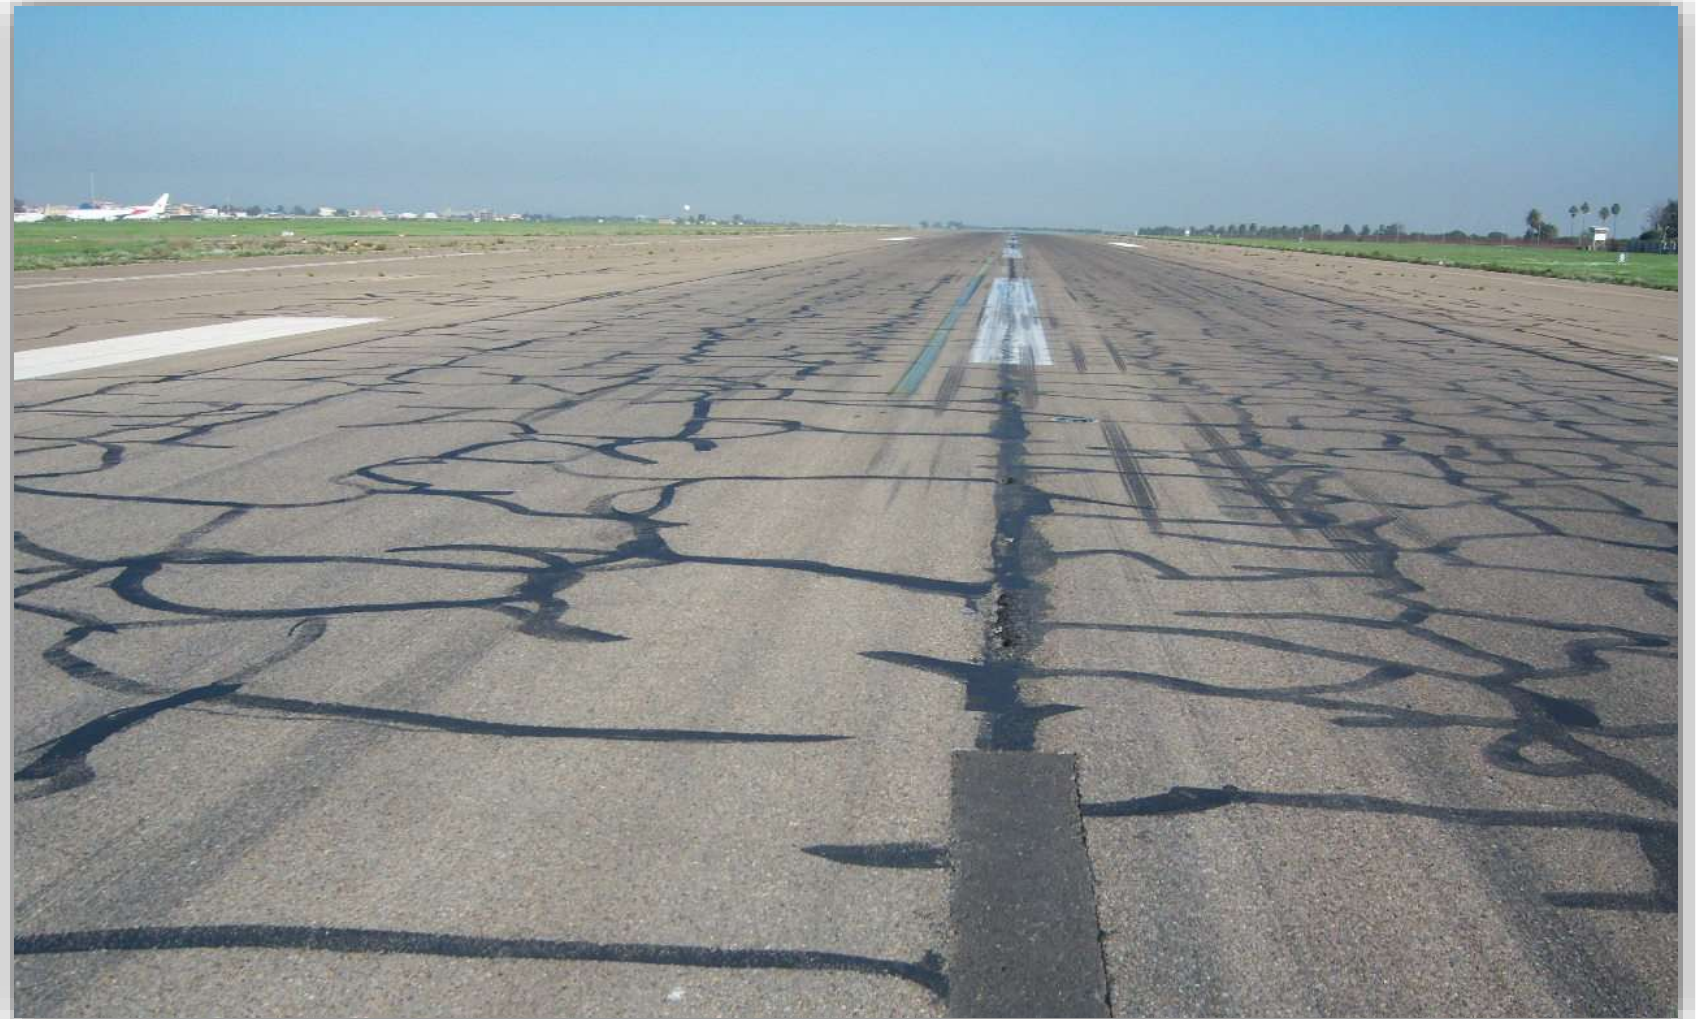
### Testing

- Scan with geo-radar
- Soil samples lab tested
- Complete runway profile
- Heavy weight deflectometer tests
- Core samples (bituminous and concrete layers)

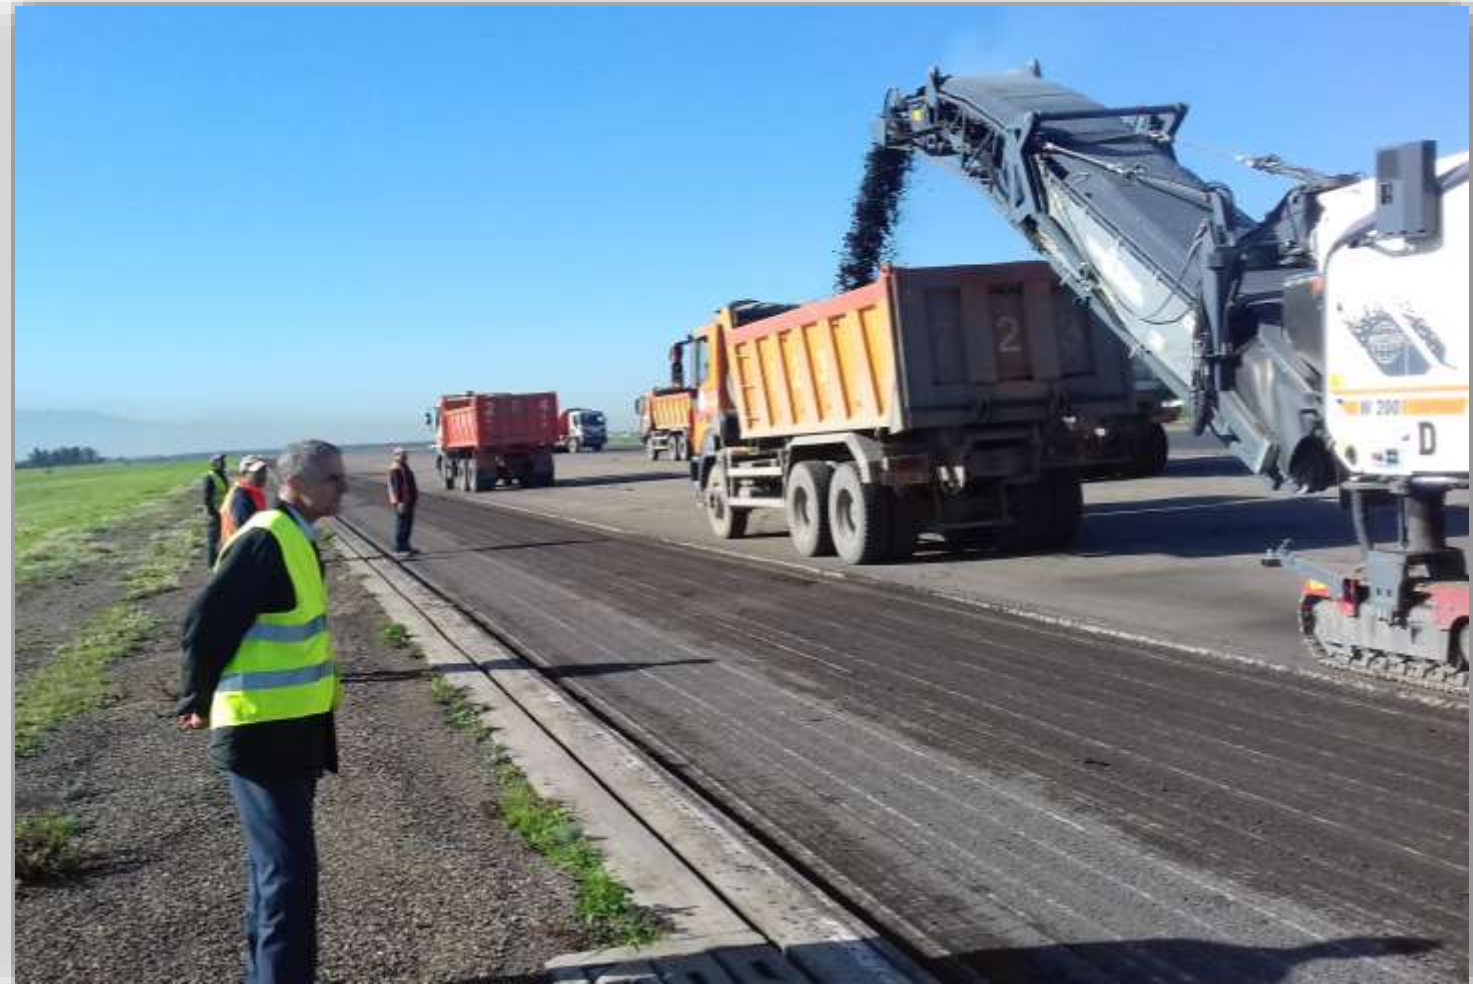
### MAIN RUNWAY REHABILITATION

0 - 1 200 m

- milling of the existing asphalt layers exposing the prestressed concrete slab;
- high modulus bituminous dense mix reinforcement (average thickness of 20 cm);
- reinforcing glass fiber grid (40 x 40mm);
- high modulus bituminous concrete wearing course, 8 cm thick.

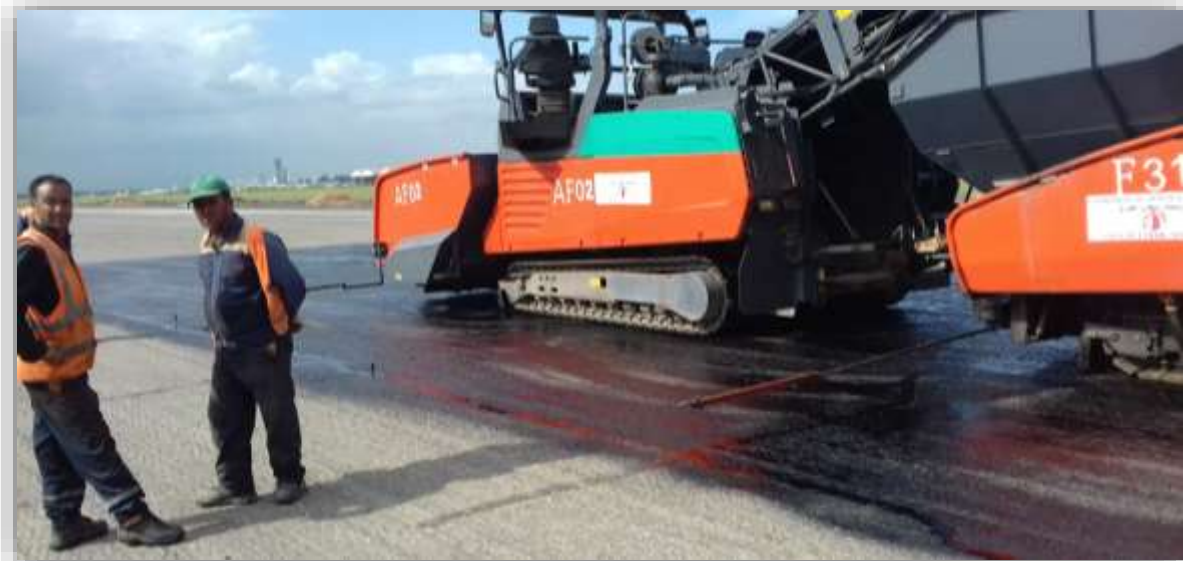
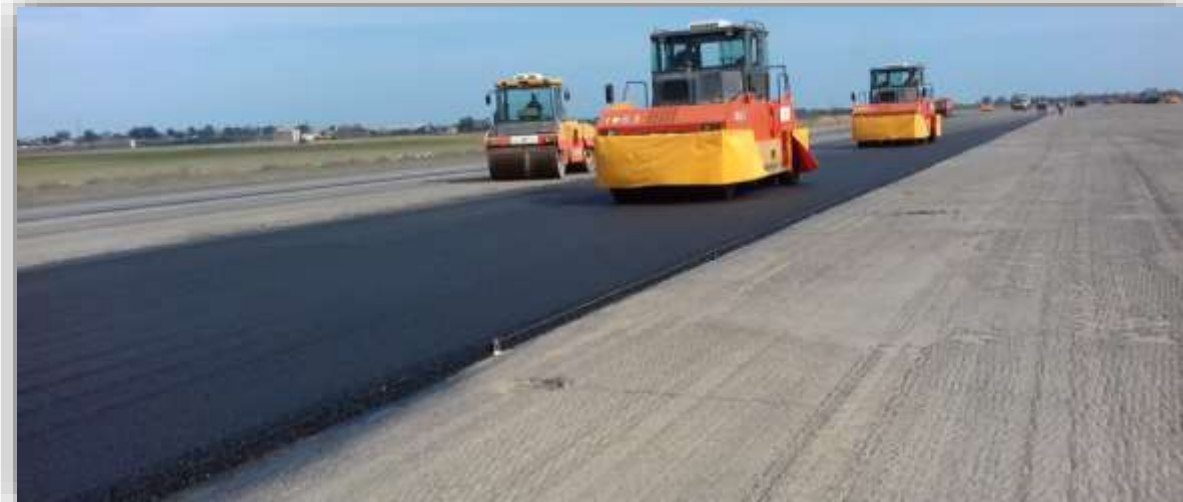
### MAIN RUNWAY REHABILITATION 1200 to 3500 m

- milling of the existing asphalt layers to a depth of 8cm
- high modulus bituminous dense mix reinforcement (average thickness of 15 cm);
- reinforcing glass fiber grid (40 x 40mm);
- high modulus bituminous concrete wearing course, 8 cm thick.

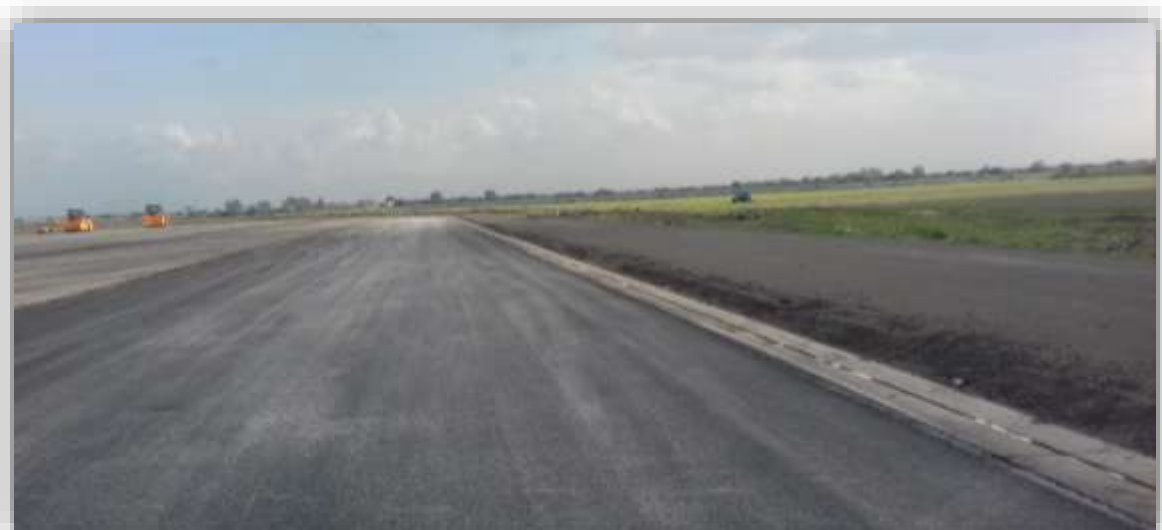
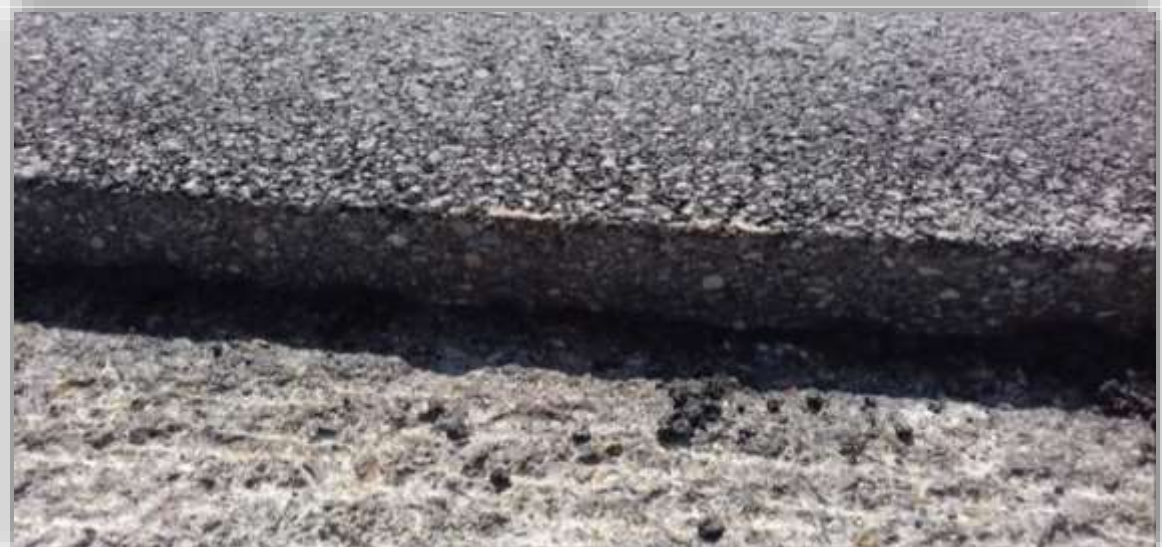
### SITE SITUATION

- milling of the existing asphalt layers - COMPLETED
- high modulus bituminous dense mix reinforcement – IN PROGRESS
- reinforcing glass fiber grid (40 x 40mm) – IN PROGRESS
- high modulus bituminous concrete wearing course – TO BEGIN AFTER INSTALATION OF RUNWAY LIGHTING CABLES

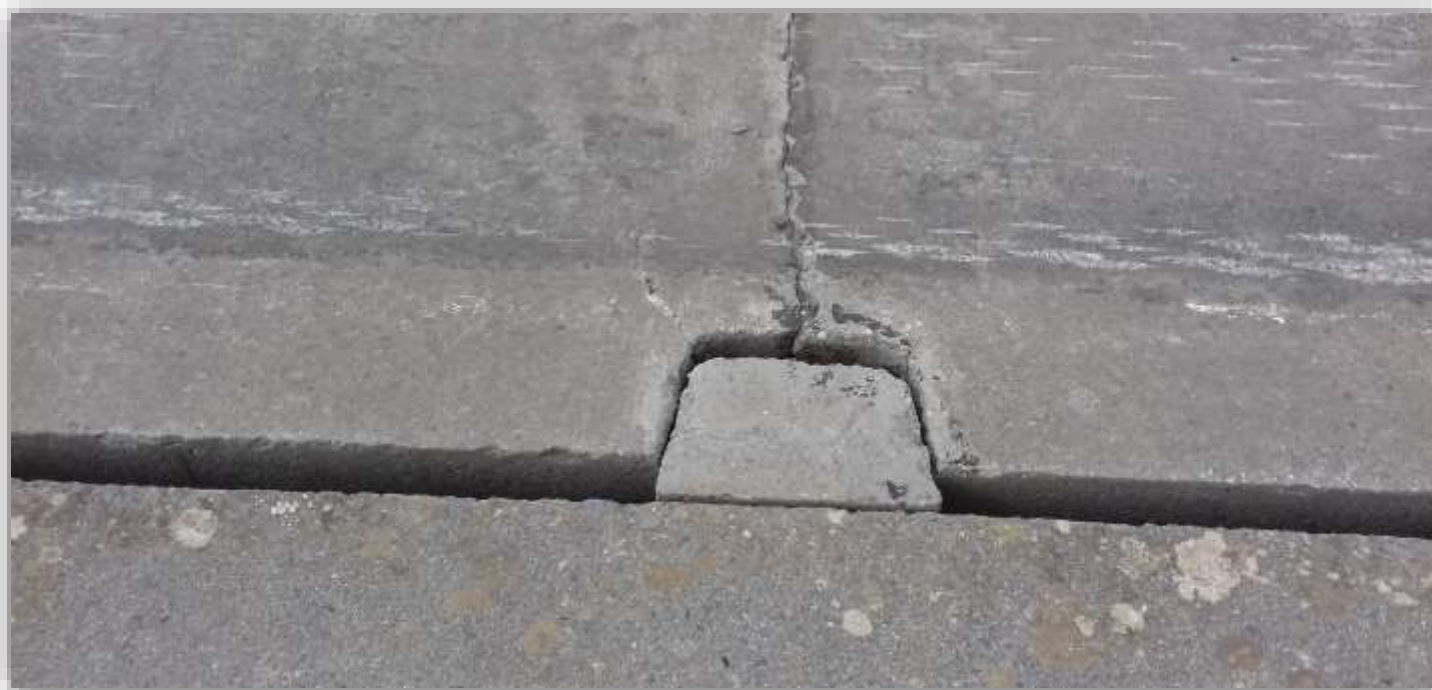
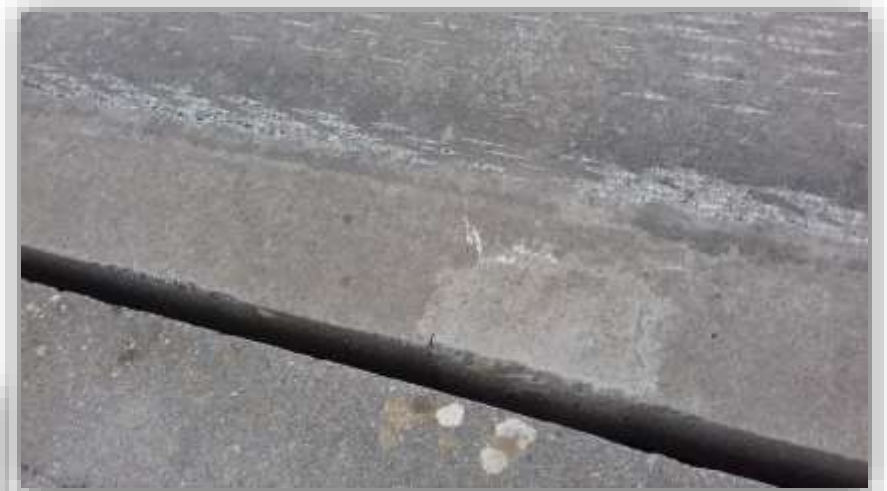
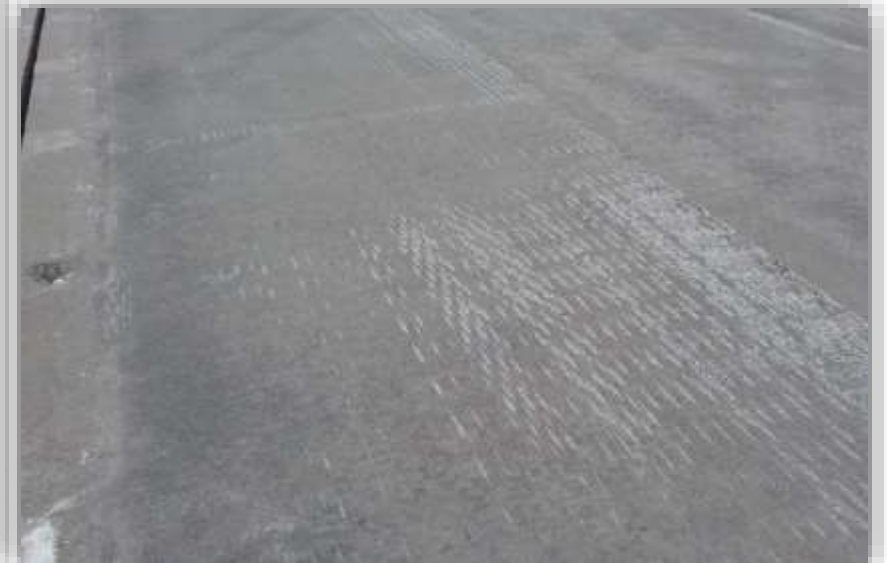
Original prestressed slabs

- Overall good quality of anchor heads
- Only one failed in 2500 m
- Excellent quality of the concrete

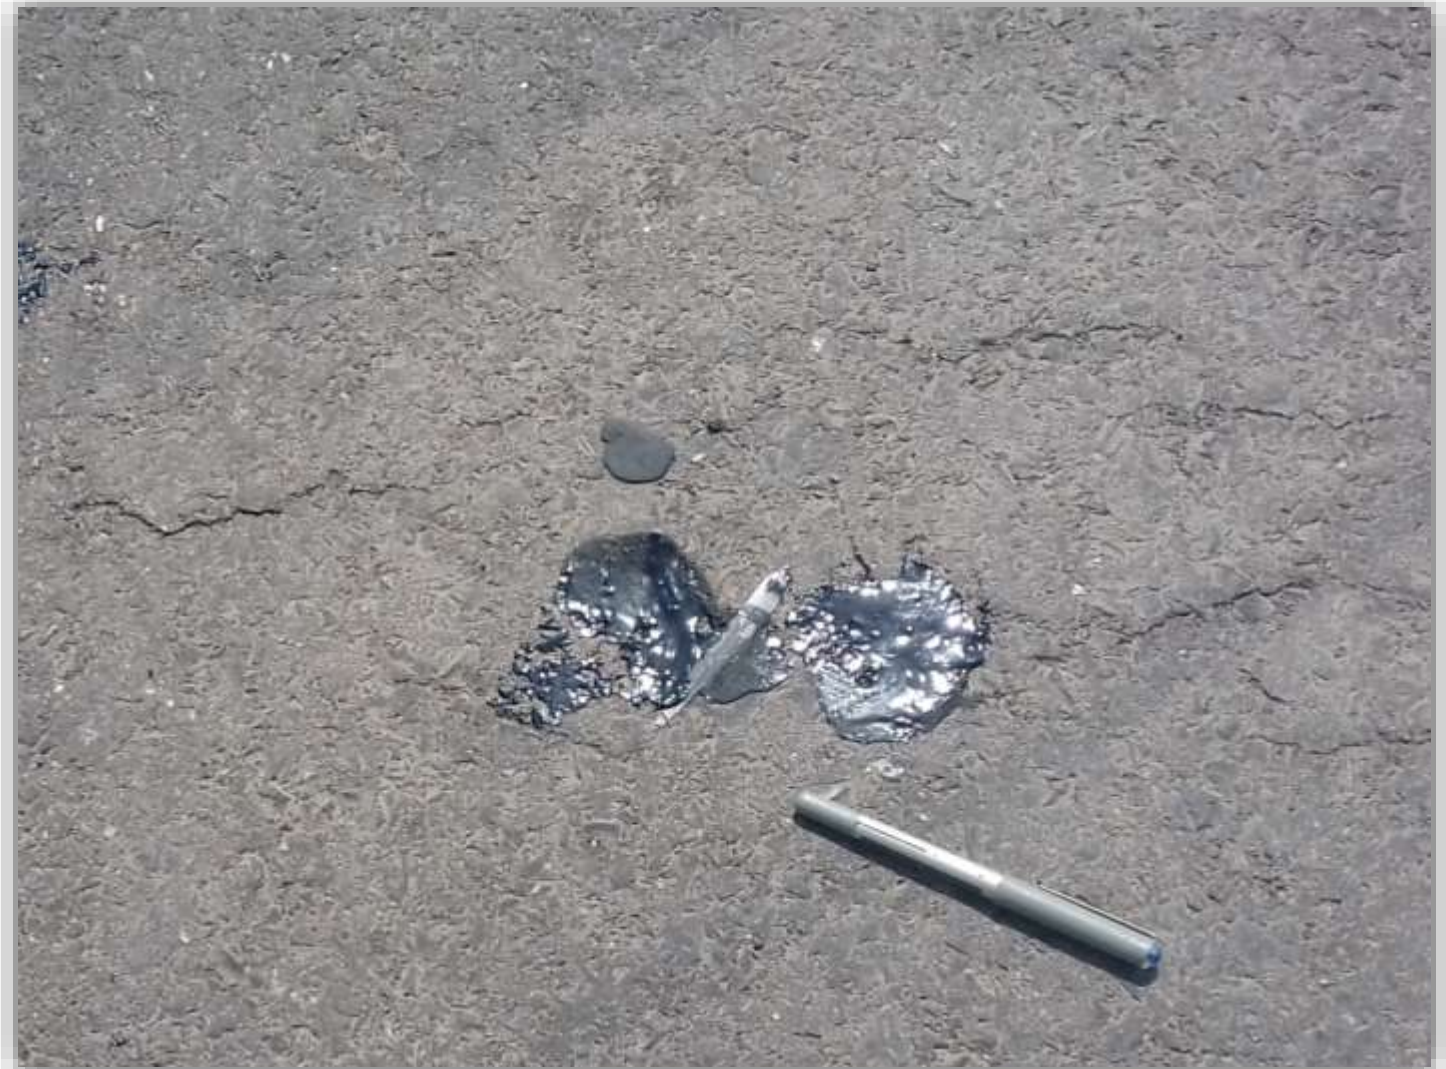
Problems with the high modulus bituminous mix (here at the maintenance apron).

- Adverse additive reaction with the bitumen.
  - A change of material solved the problem;
  - In 4 weeks the bituminous layer gained the specified modulus as the solvents evaporated.

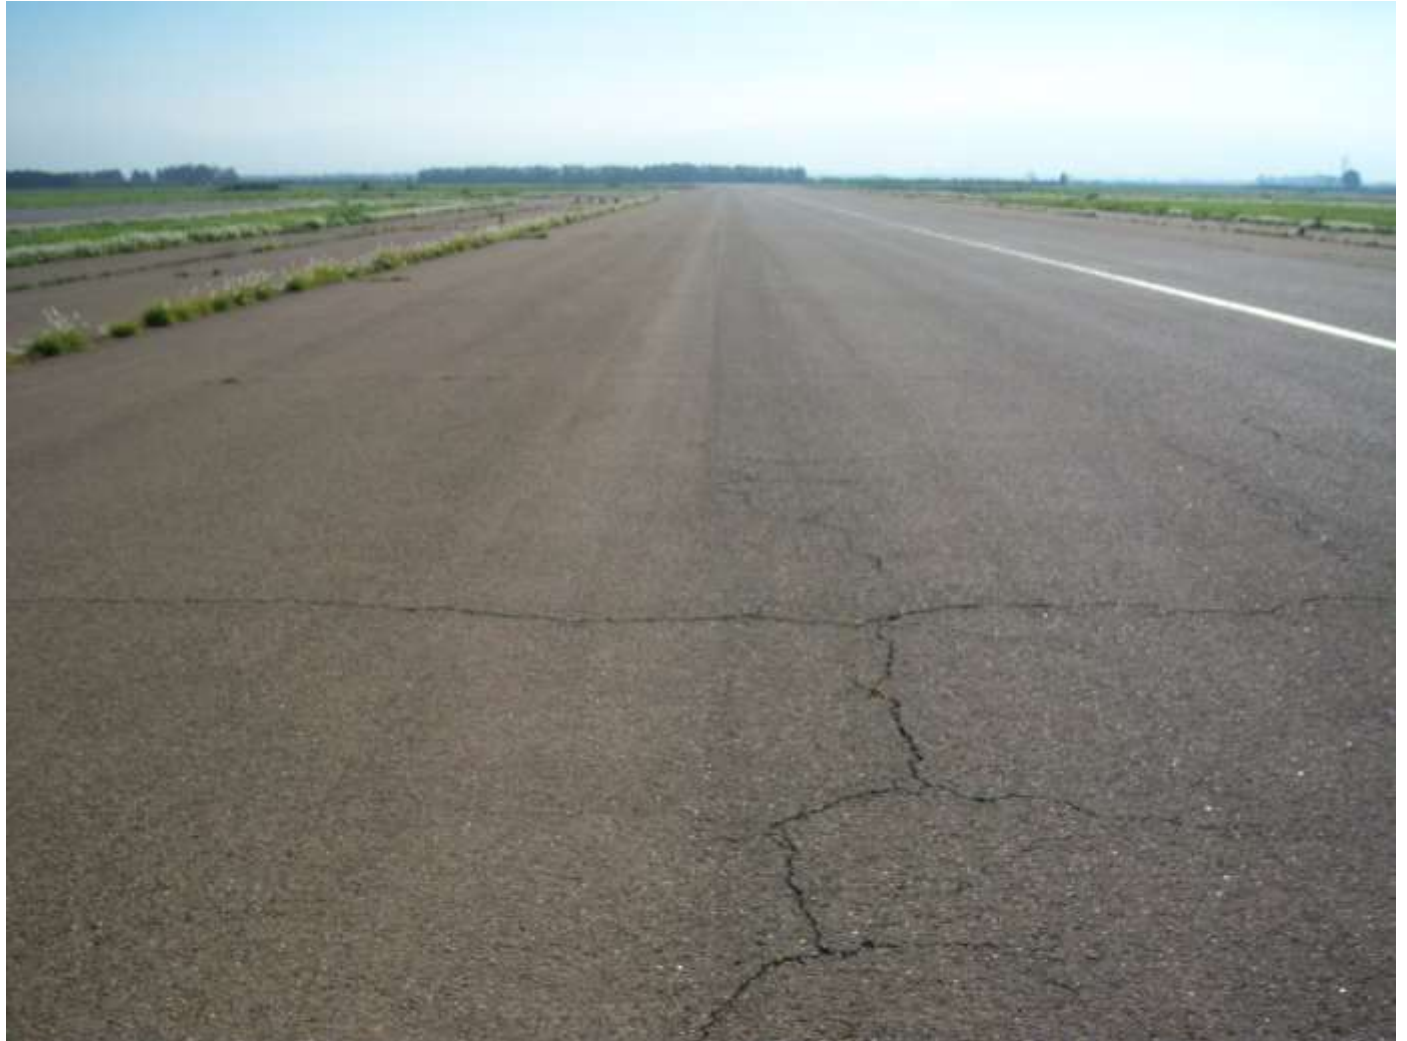
### PARALEL TAXIWAY AND ACCES TAXIWAYS REHABILITATION

- Milling of the existing asphalt layers to a depth of 8 cm;
- high modulus asphalt concrete reinforcement with an average thickness of 10 cm.

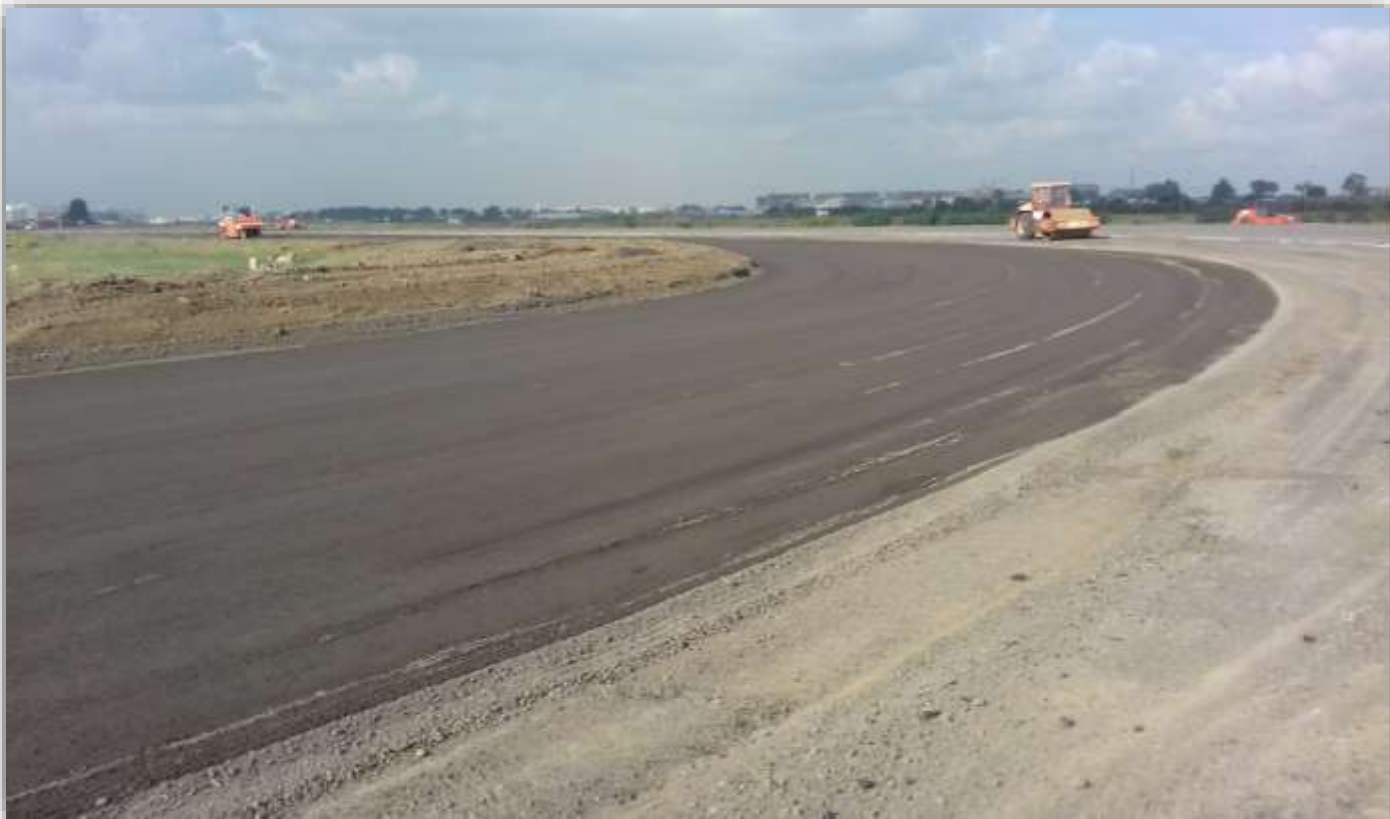
Widening of the taxiway pavement at intersections and shoulders to accommodate Airbus 380 (simulation using Civil 3D)

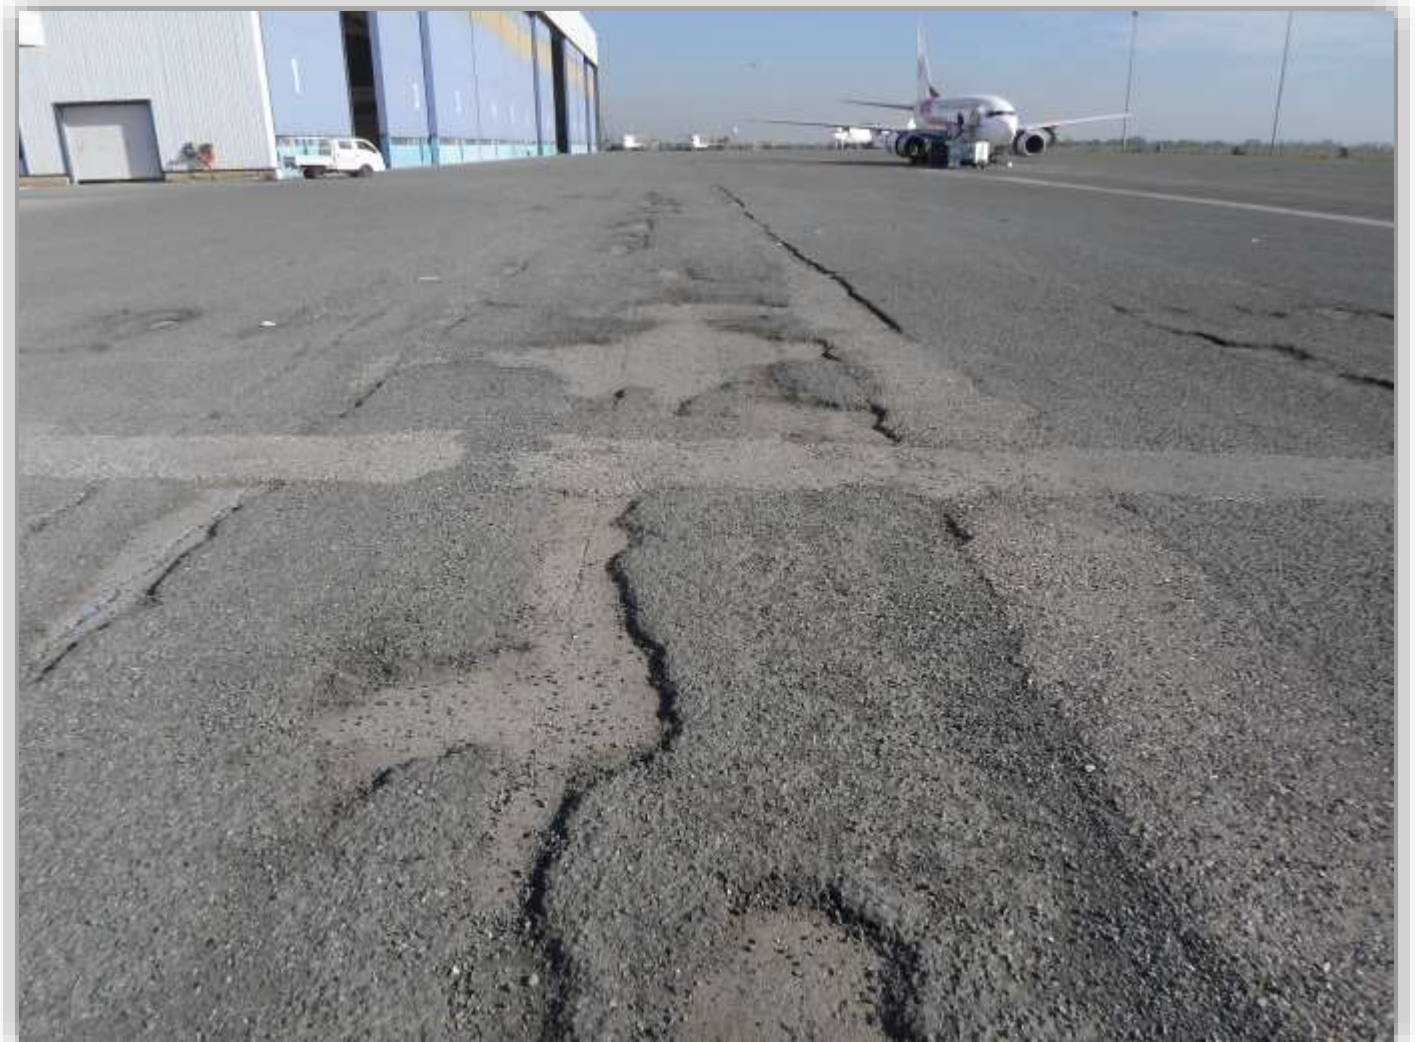
#### Apron GLAMM 2

- Milling of the bituminous layer
- Sealing of concrete slabs joints
- Reinforcement with glass fiber grid
- High modulus bituminous concrete reinforcement (10 cm average thickness)

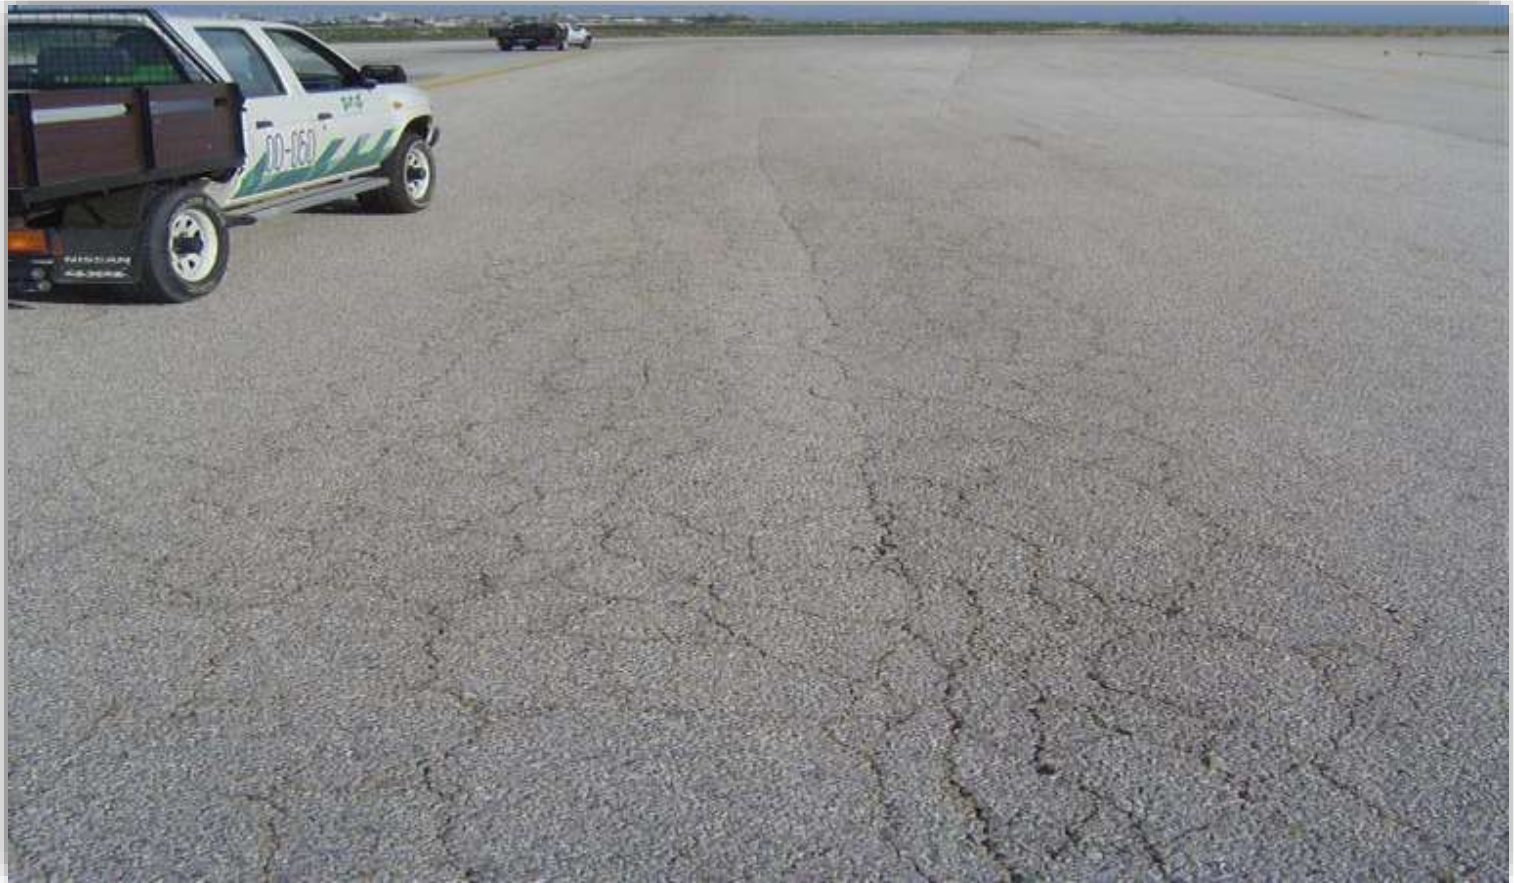
- Pavement in very poor condition
  - 40% of surface showing alligator cracking
  - 34% with raveling
- PCN (pavement classification number) ranging from 21 to 31

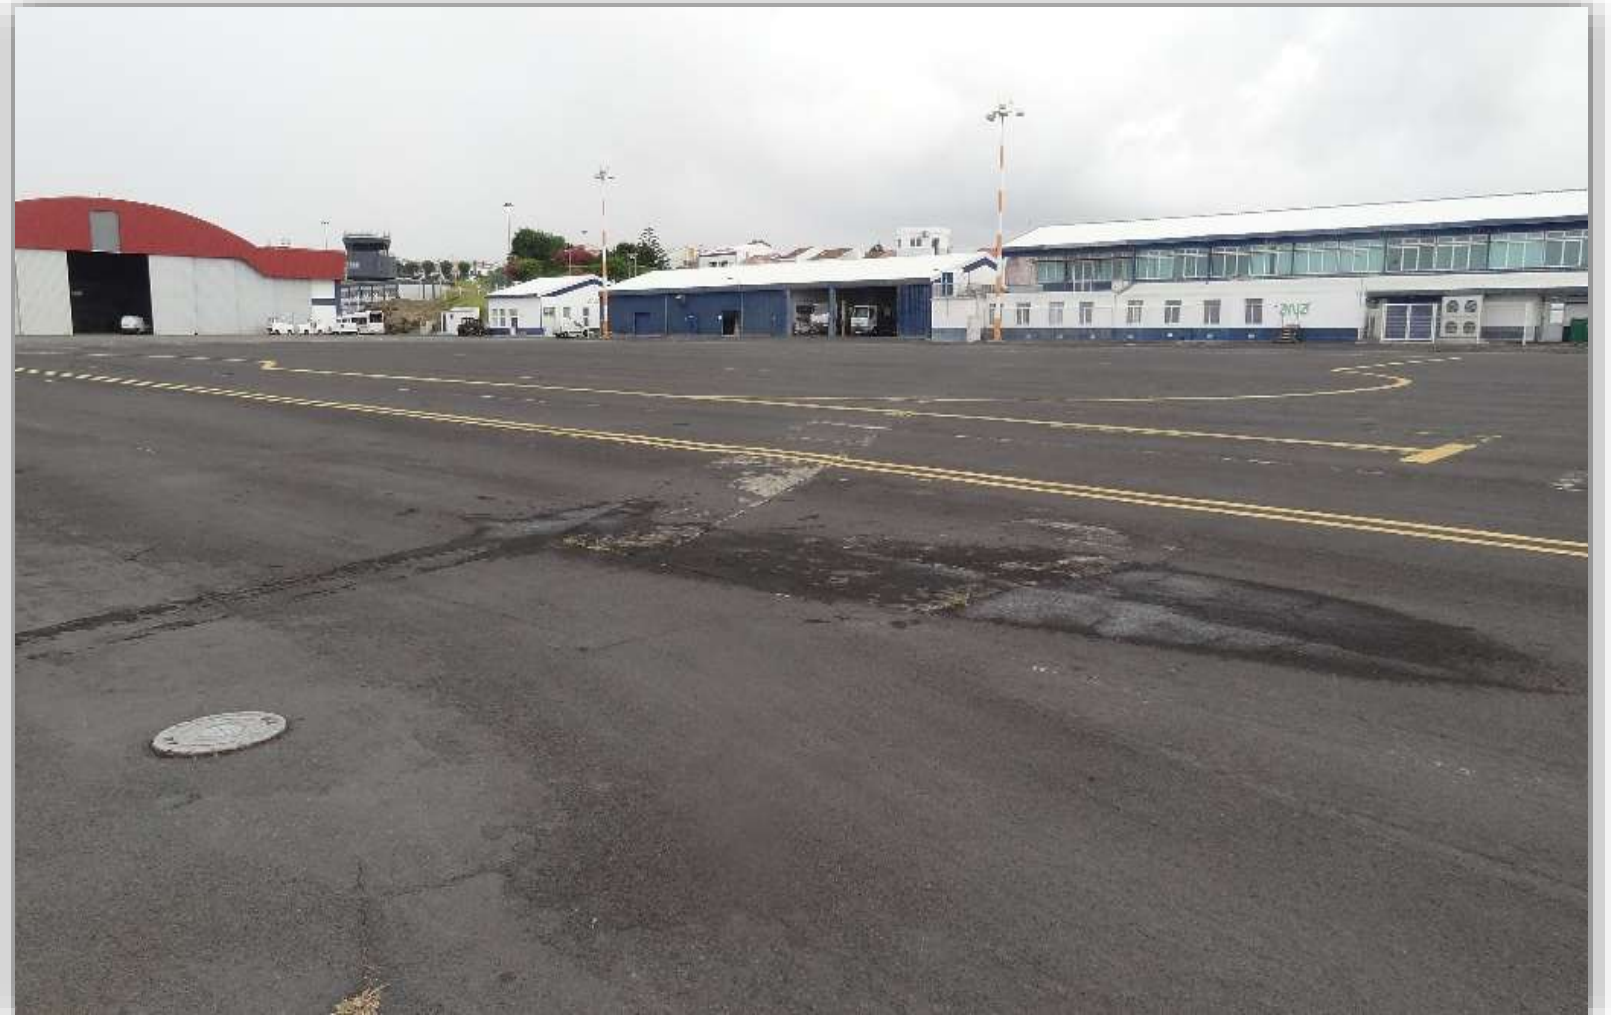
Flexible pavement:

- 7 cm of bituminous layers;
- 5 cm of bituminous semi-penetration layer;
- 15 cm of tout venant layer.

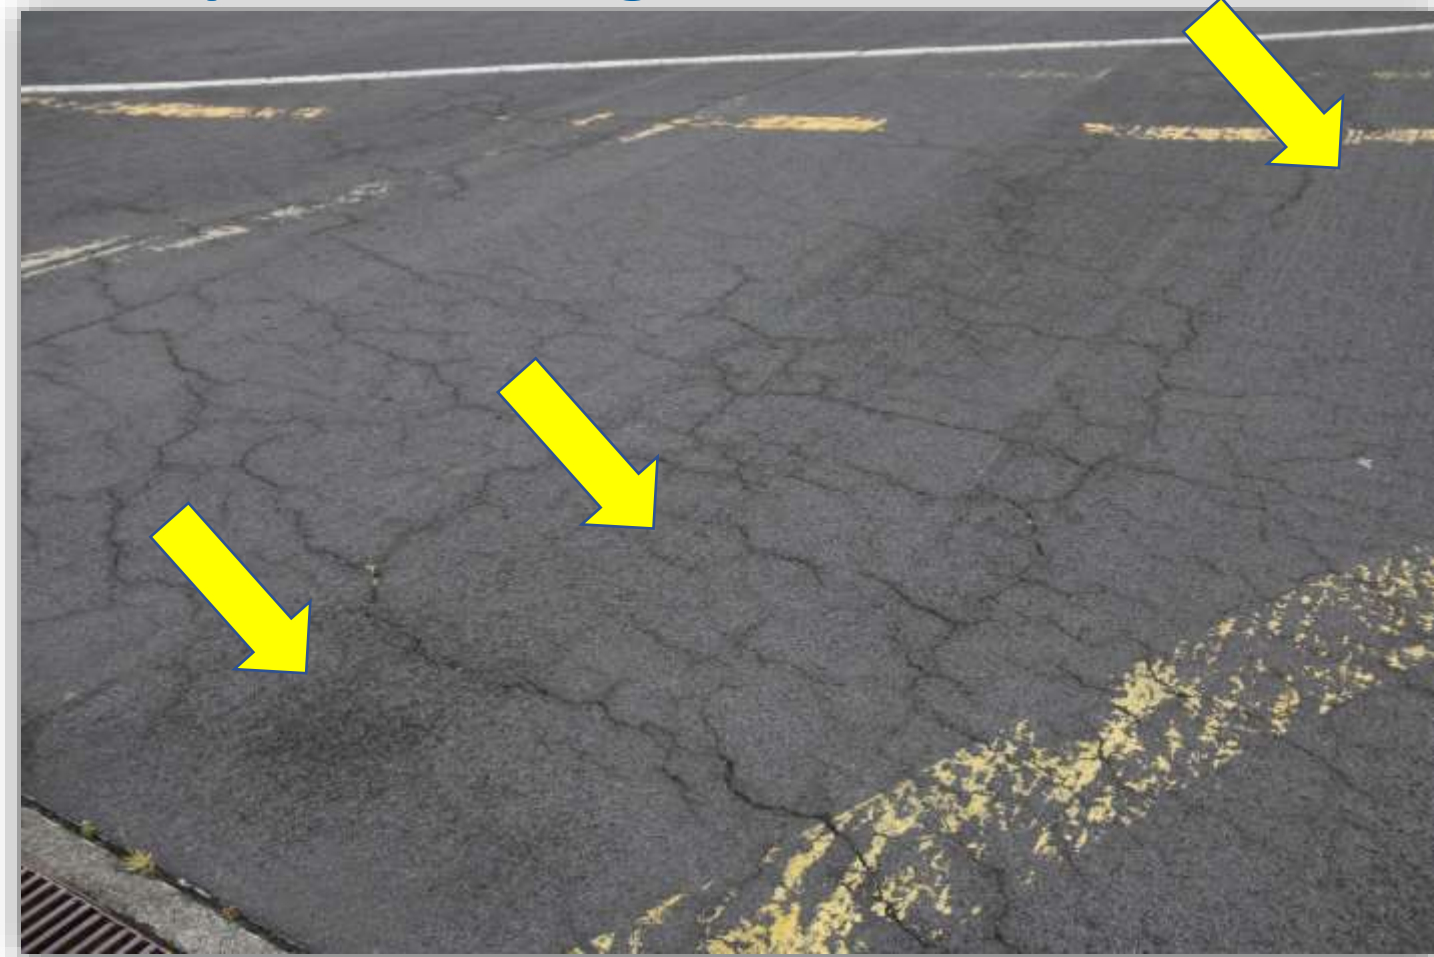
- Alligator cracking;
- Longitudinal and transverse cracking (fatigue cracks);
- Raveling (with loss of material);

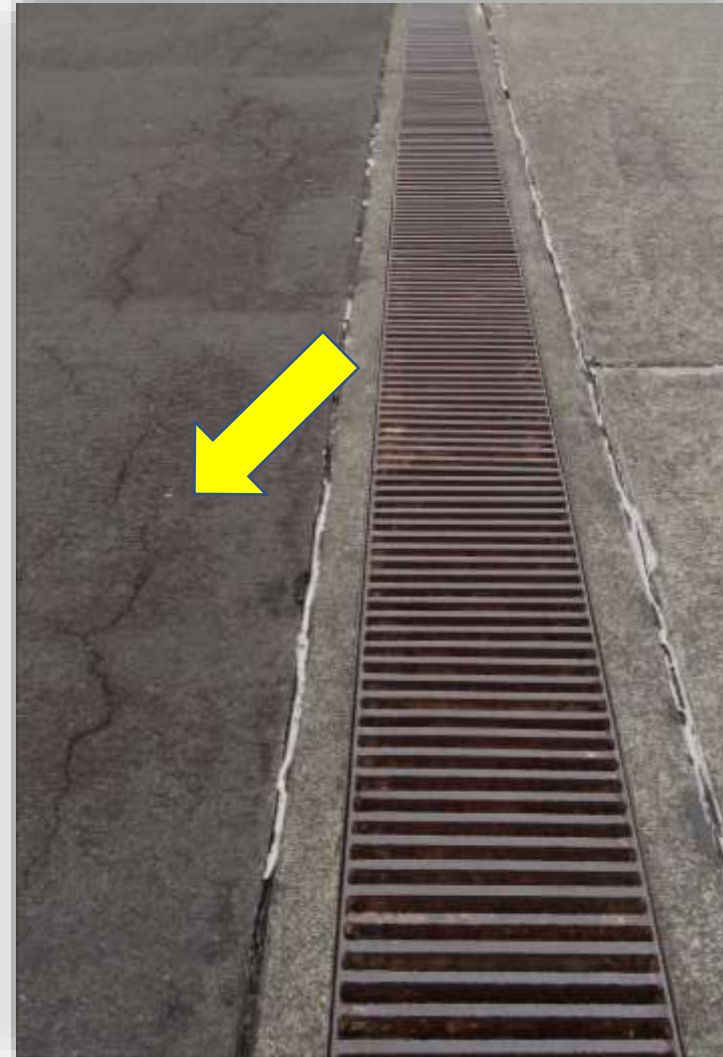
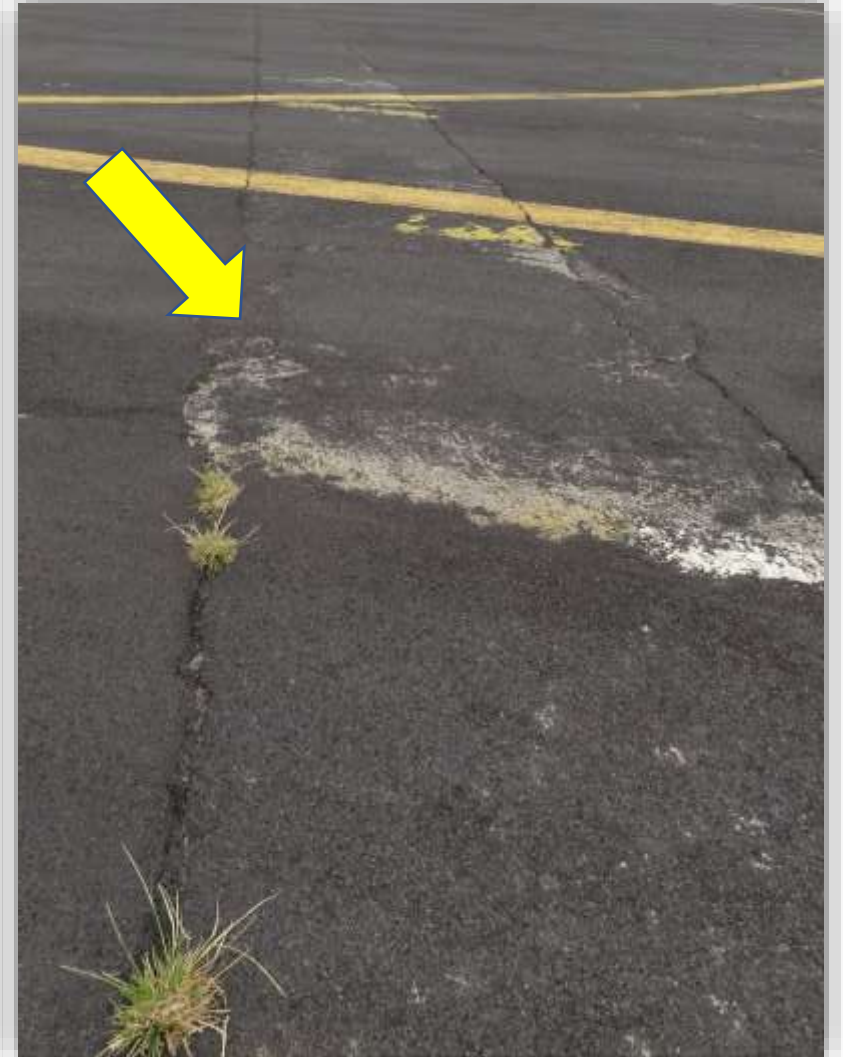
- Longitudinal and transverse cracking (along the rigid pavement and shoulders);
- Patching (with open fissures along the edges).
